RELEASE NOTE SUMMARY

Overview

This document provides a compilation of Release Notes that have been published by Industrial Scientific to date. *Table 1. Document Summary* provides a list of instruments, version numbers, release dates, and a brief overview of each Release Notes document. Following Table 1, you will find a copy of the complete version of each document.

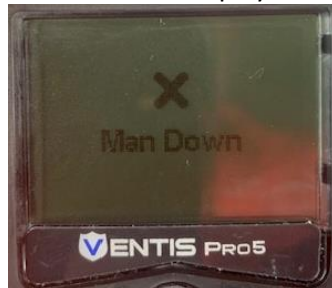
- Fix for the sensor position 3/4 error (TS-71, VPRO-622)
- Fix for the false error 672 – Man Down/Accelerometer error (TS-1559, VPROFIRM-796)
 - Issue: FW v5.00.32 falsely triggered an error causing the Man Down alarms turn off
 - Ventis Pro will display the following message when the error occurs:

- If an instrument already had this error, please follow the steps below:
 - Schedule the firmware upgrade to v5.00.34
 - Dock to update the firmware
 - Undock / DO NOT turn on
 - Take the battery off
 - Wait ~1 min
 - Install the battery back on
 - Re-dock
 - Force a Bump Test
 - Undock / Turn it on
